Assessment of Scour Levels at the Indus River Bridge Crossing, Pakistan

Project period: 1997

Client: Government of Pakistan
National Highway Authorities

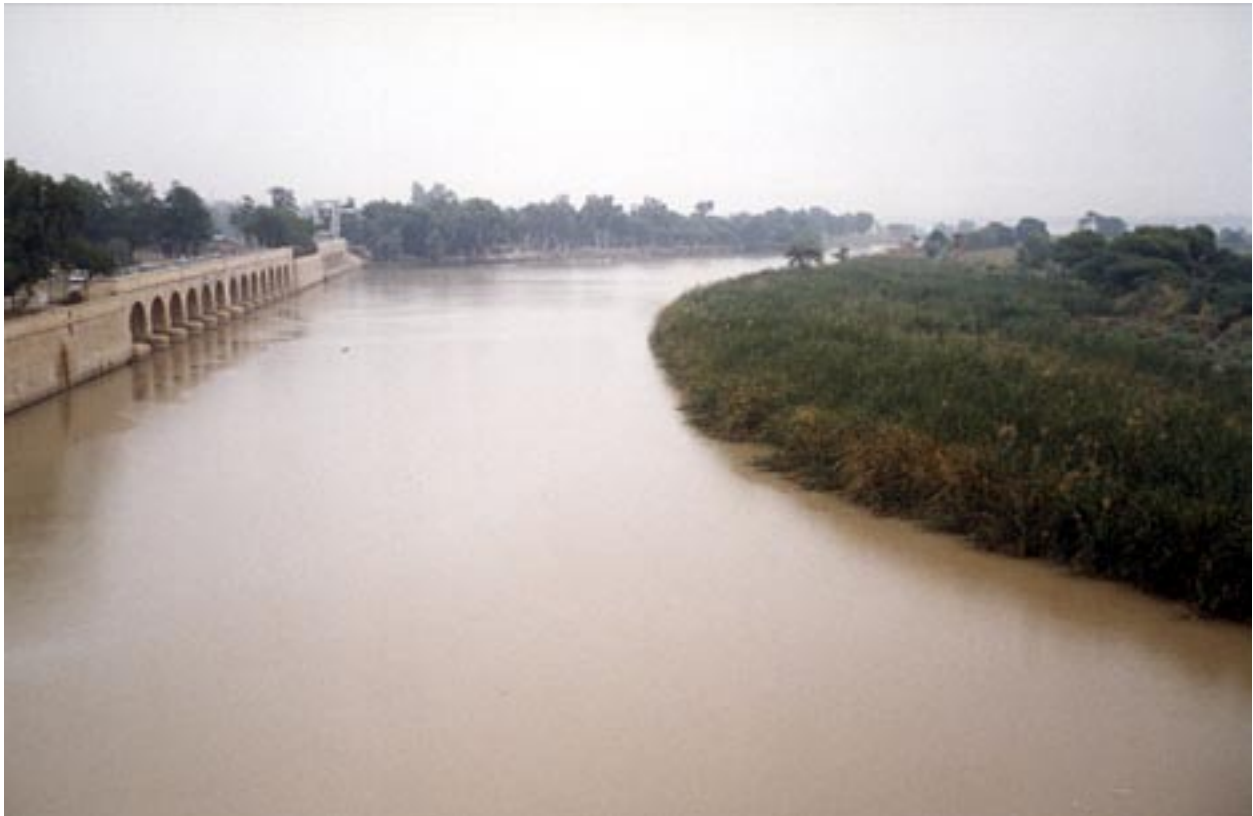
Upstream irrigation channel weir (left). Artificial island (right) which developed in the early years of operation as a result of excessive siltation at bays 6-10.

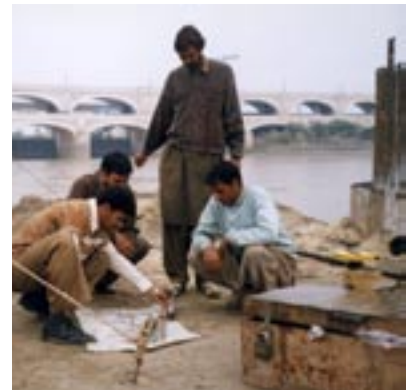
Execution of confirmatory borings at the bridge piers. A newly constructed pile at the right and the upstream Sukkur Barrage in the background.
